UK Bulk Material Handling Company

Dust Fan, Unbalance, March 21

Case Study No: 0047

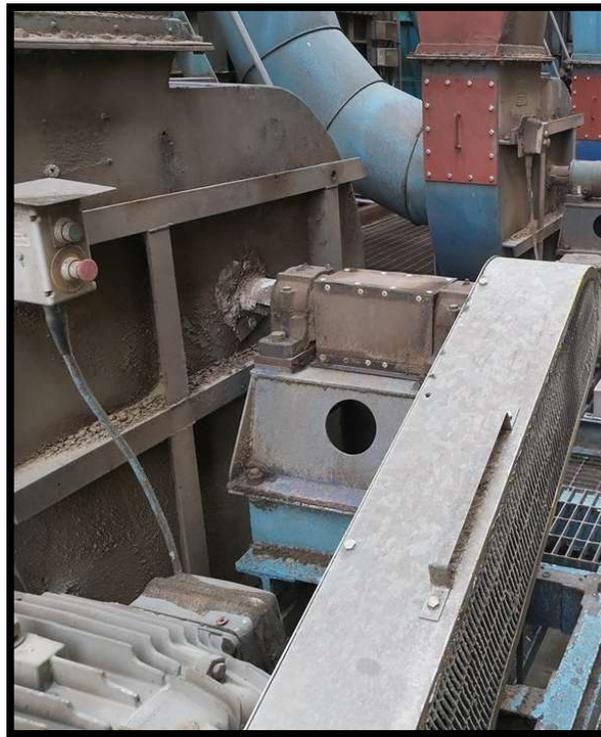
Dust Fan #2

The monthly vibration routines detected high vibration levels for the velocity domain on the fan bearings. The in-house analysis concluded that high levels of unbalance were the cause of the elevated vibration levels. Due to the 24 hour operation of this asset, RJW engineers monitored the trends until it was decided that the work needed to be completed at the next opportunity.

Pre fault identification (Velocity)	Post remedial work (Velocity)
Fan NDE Horizontal	62.8 mm/s	3.06 mm/s
Fan NDE Vertical	13.70 mm/s	1.22 mm/s
Fan NDE Axial	6.38 mm/s	3.69 mm/s

During the site visit, the RJW engineers inspected and cleaned the impeller and carried out an in-situ balance of the impeller. This work reduced the overall vibration levels to a satisfactory level.

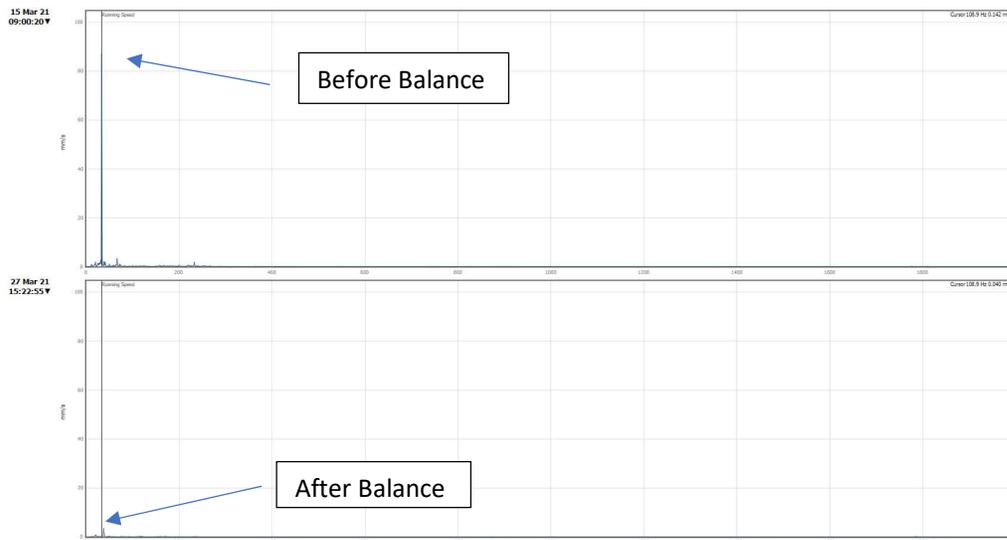
From the investigation we managed to reduce the vibration levels to a satisfactory level. In the spectra below we can see the reduction in the fan 1x running speed.
