## Large UK Food Manufacturer

### Exhaust Fan Unbalance

Case Study No: 0045

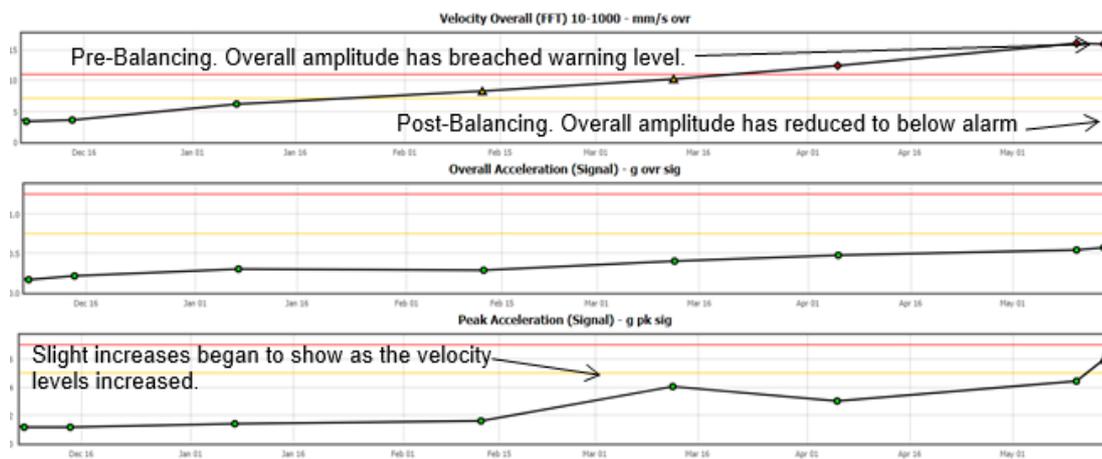
Vibration data collected from the fan Non-Drive End (NDE) began to increase steadily over a period of 6 months until finally breaching the high warning threshold, early analysis of the spectra data showed a dominant peak at 1x running speed in the radial and axial velocity readings, this indicates unbalance in the impeller of an overhung fan. In figure 2 we can see the spectrum for the fan NDE horizontal velocity reading, the spectrum is dominated by a peak at 28.2Hz (1692 RPM), this peak is the unbalance component in that spectrum. Over this period of 6 months, we saw some slight increases in the acceleration readings in the fan bearings indicating that the extra forces acting upon them from the unbalance had not yet damaged the bearings, but the forces were beginning to cause strain. Subjecting bearings to prolonged exposure to the forces generated by unbalance will lead to catastrophic failure of the bearings and other components. Rotating unbalance is defined as the uneven distribution of mass around an axis of rotation, in basic terms this is a heavy or light spot on the fan impeller usually a build-up of product / dirt on the blades or damage to the impeller. As fans are balanced dynamically prior to being installed it was decided to inspect the impeller and clean it using a combination of scrapers and high-pressure jetting, this would return the impeller back to a condition it was prior to being installed & should reduce to the vibration amplitude enough to continue long term operation of the fan without needing a trim balance, and as we can see in the latest reading in figure 1 this proved to be the case.

Figure 1: Fan NDE horizontal vibration trend over 6 months

The fan impeller was inspected and found to have build-up of product on the impeller; this would have been the main contributing factor to the high vibration readings. The fan was cleaned and then jetted using high- pressure water to remove the build-up of product from the fan blades. Once the impeller was, clean all velocity levels reduced to be below alarm and no trim balancing was required

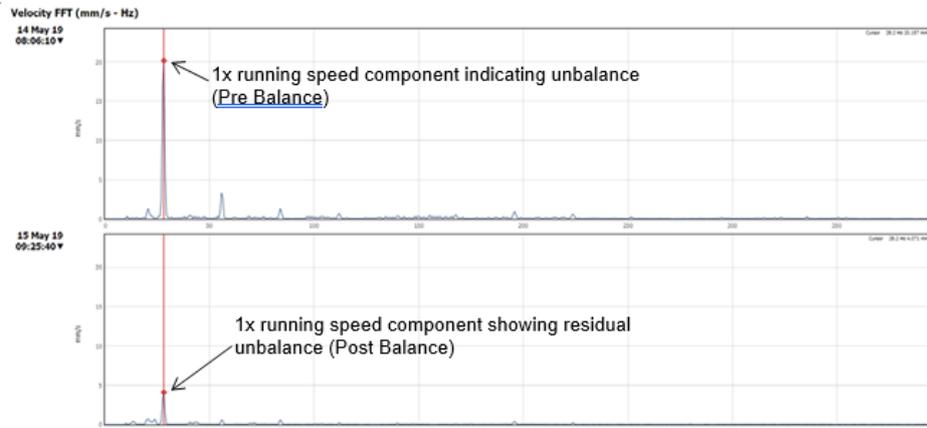
Figure 2: Fan NDE horizontal velocity spectra show pre and post balancing.

In the table above, we can see that the all velocity readings were in alarm, following the balancing of the impeller all levels reduced significantly and are below alarm.
